INTERPRETING THE MEANING OF RITUAL SPACES:  
THE TEMPLE COMPLEX OF PUMAPUNKU, TIWANAKU, BOLIVIA

A DISSERTATION

Anthropology

Presented to the Faculties of the University of Pennsylvania in Partial  
Fulfillment of the Requirements for the Degree of Doctor of Philosophy

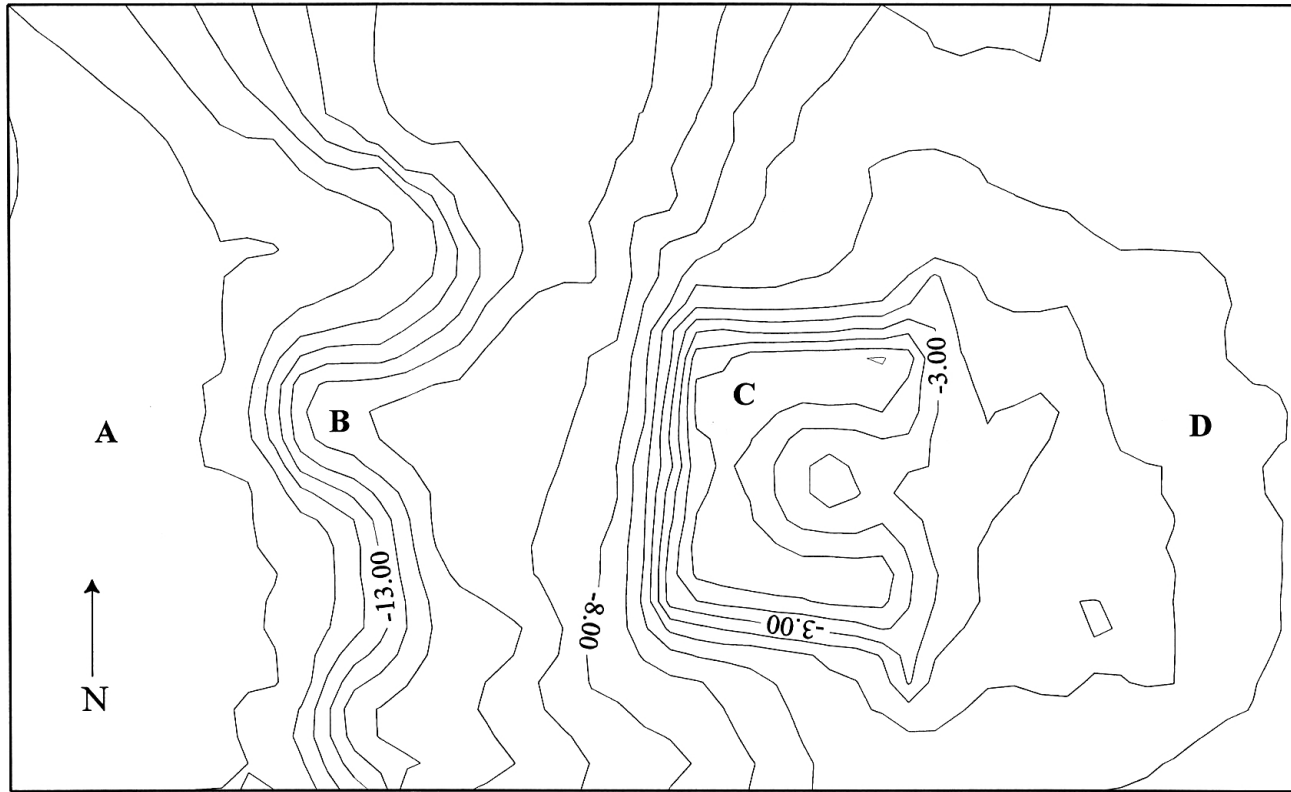
Figure 3.2: Contour Map of the Pumapunku Complex with Places Mentioned in the Text

- A Western Plaza
- B Earthen Esplanade
- C Main Platform
- D Eastern Plaza

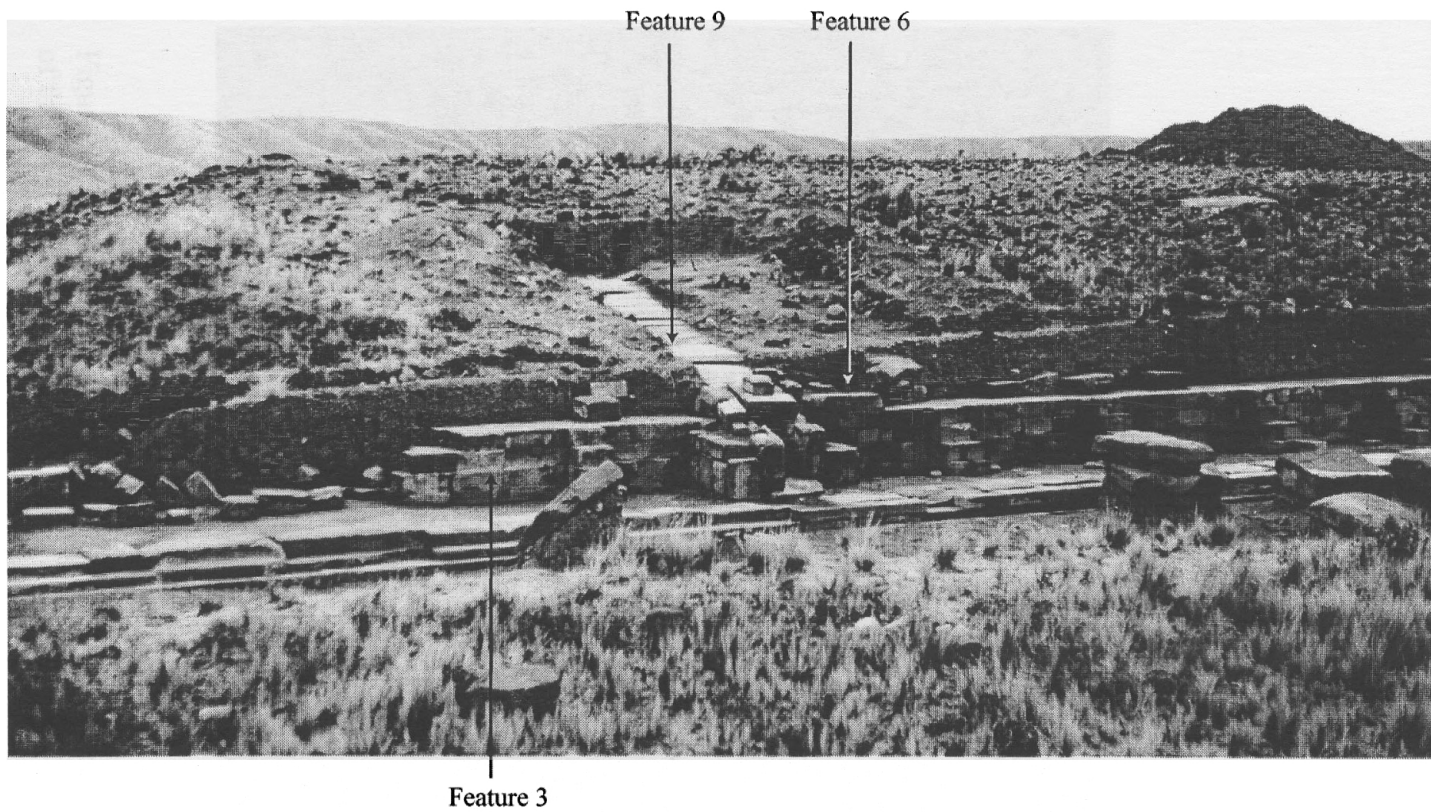
Figure 5.7: Trench P1, View Looking North at the Southwest Corner of the Main Platform.

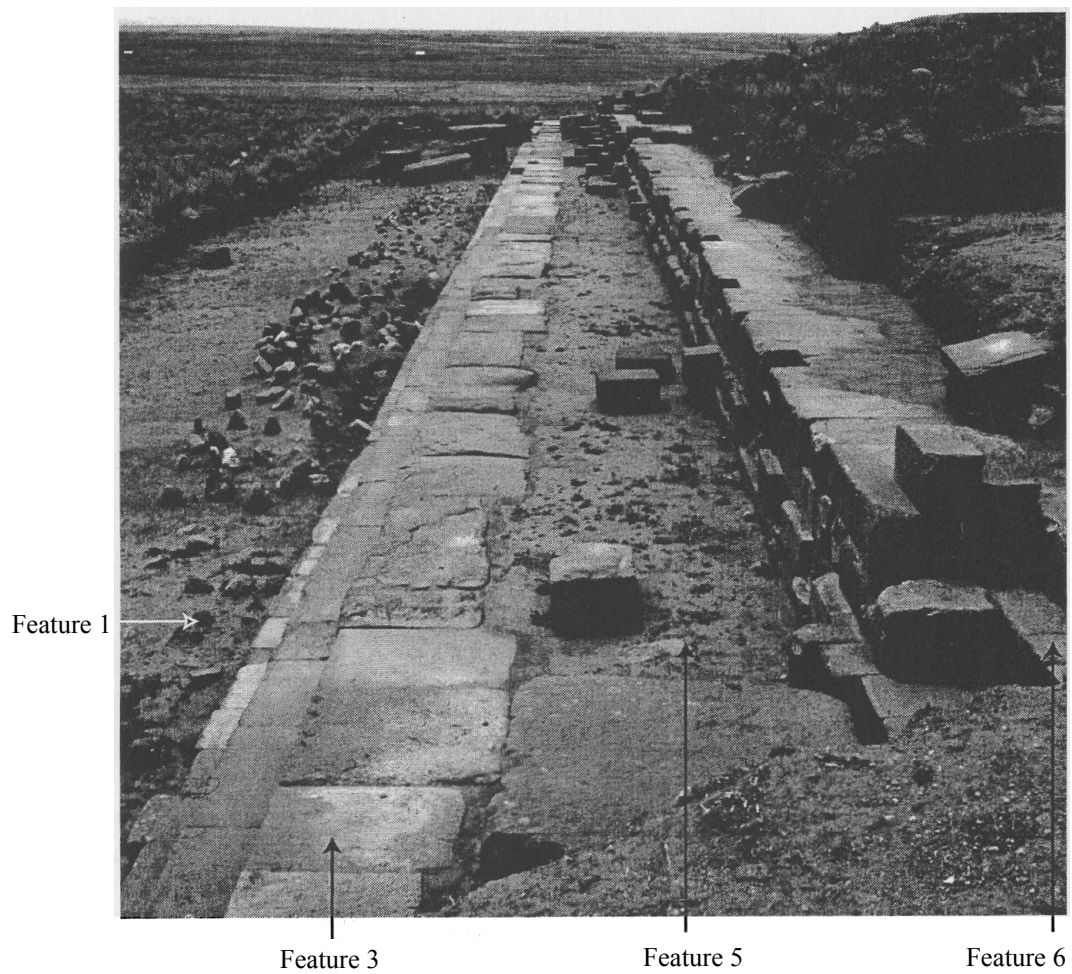
Figure 5.8: Trench P1, View Looking West along the South Side of the Main Platform.

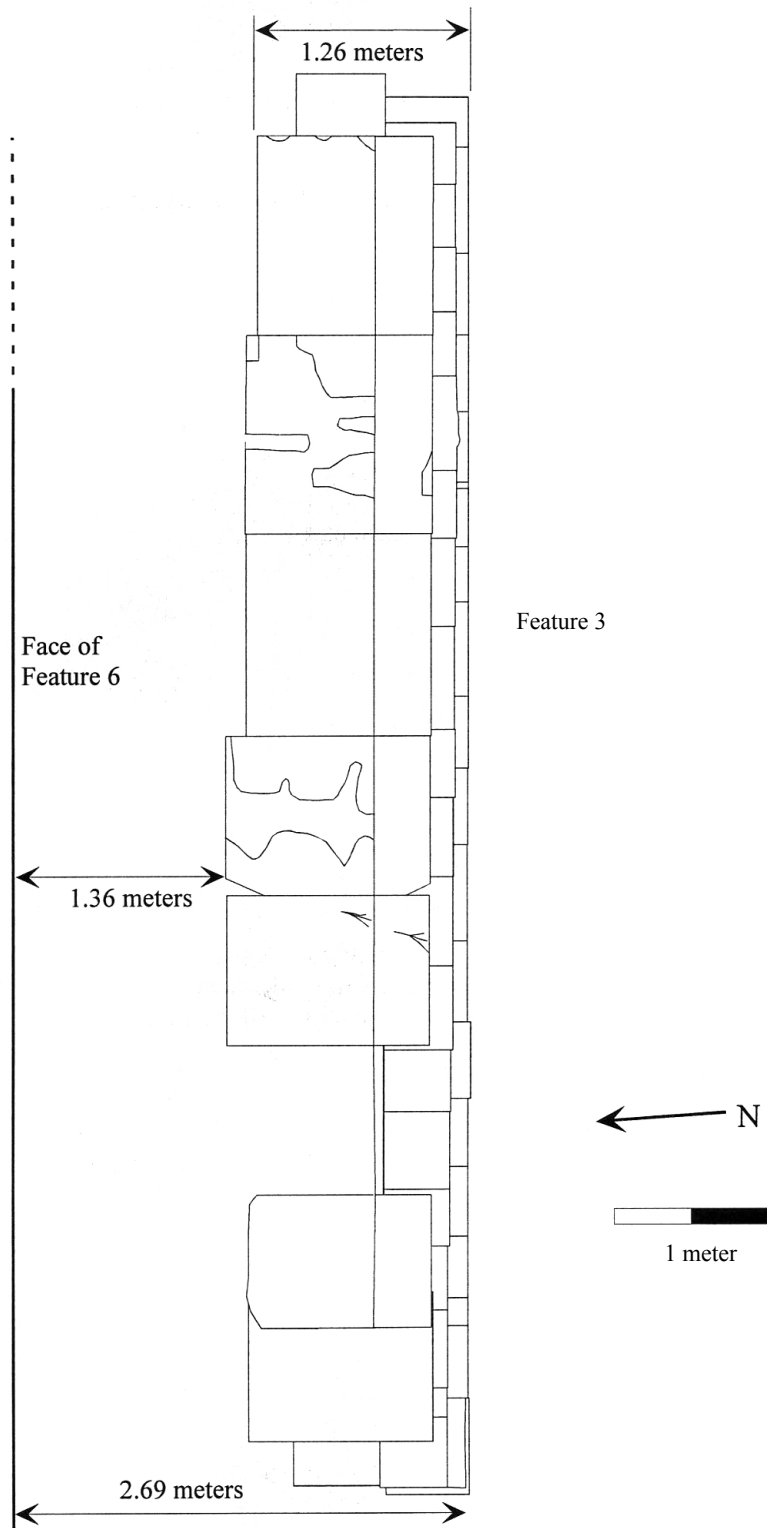
Figure 5.13: Trench P1, Feature 3. Detail Showing the Rough Surfaces of the Upper Course on the South Face of the South Wing of the Main Platform

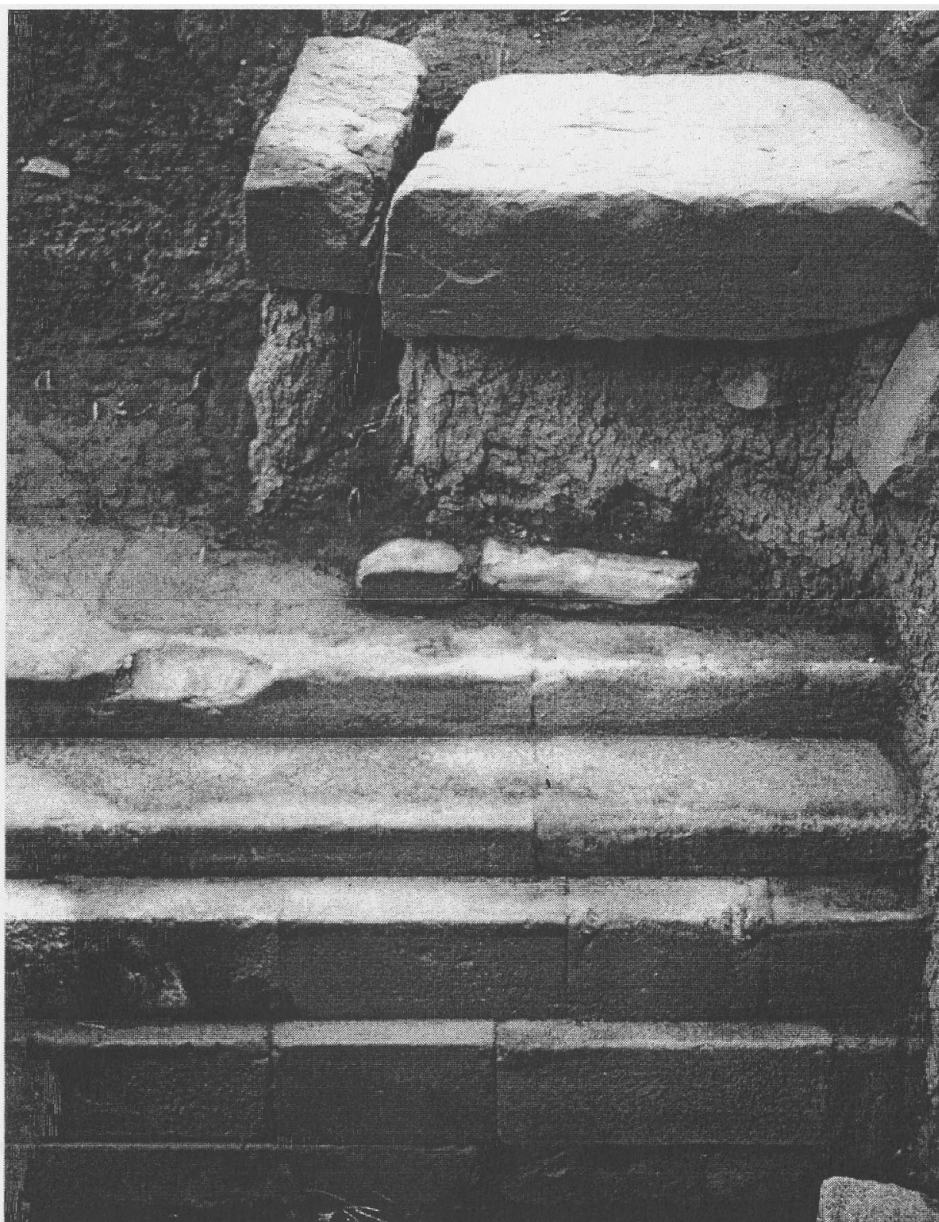
Figure 5.20: Trench P3, Feature 1. Notice the Precision Fit of the the Stone Blocks.

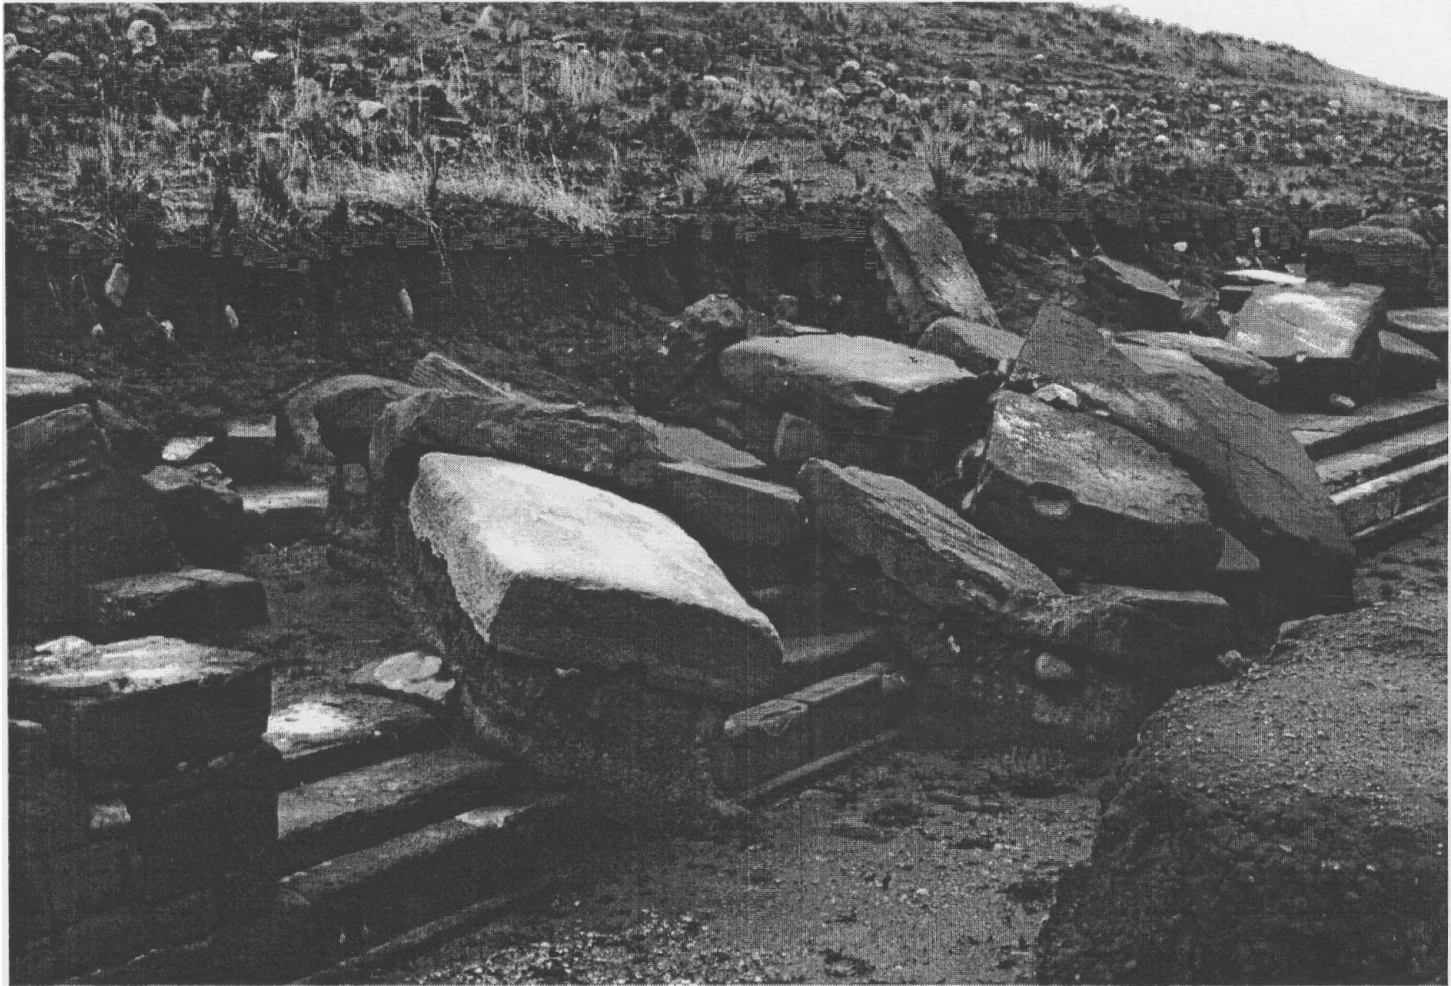
Figure 5.23: Trench P4, Feature 2. Large Stones Blocks of Feature 2 on the Even Courses of Feature 1.

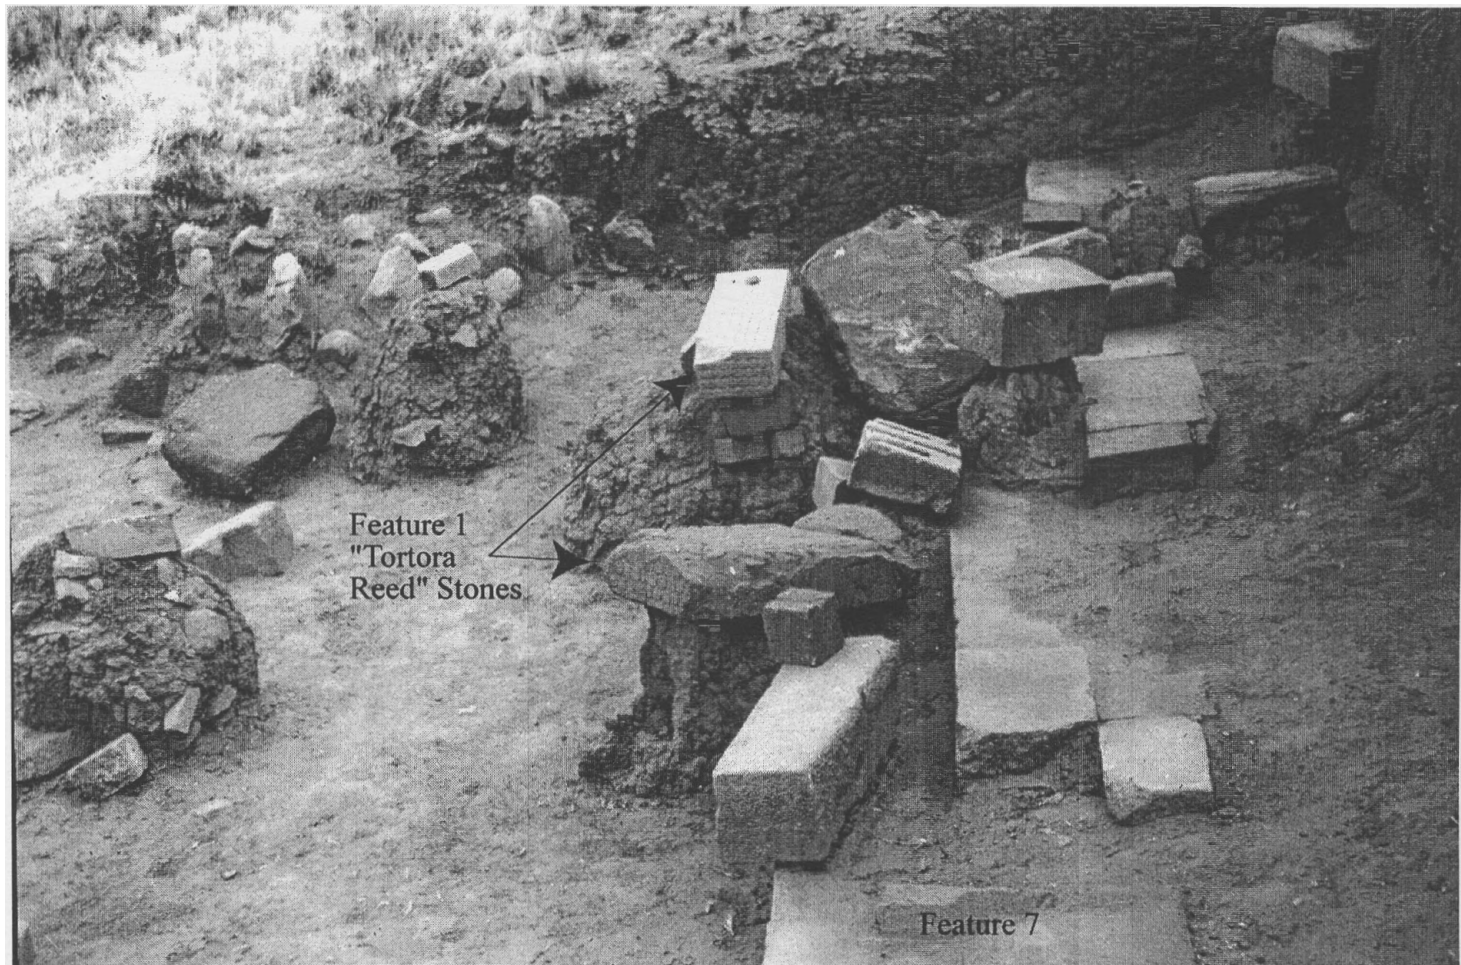
Figure 5.41: Trench P13 prior to Cleaning for This Study. Notice the Pedestalled Carved Stones.

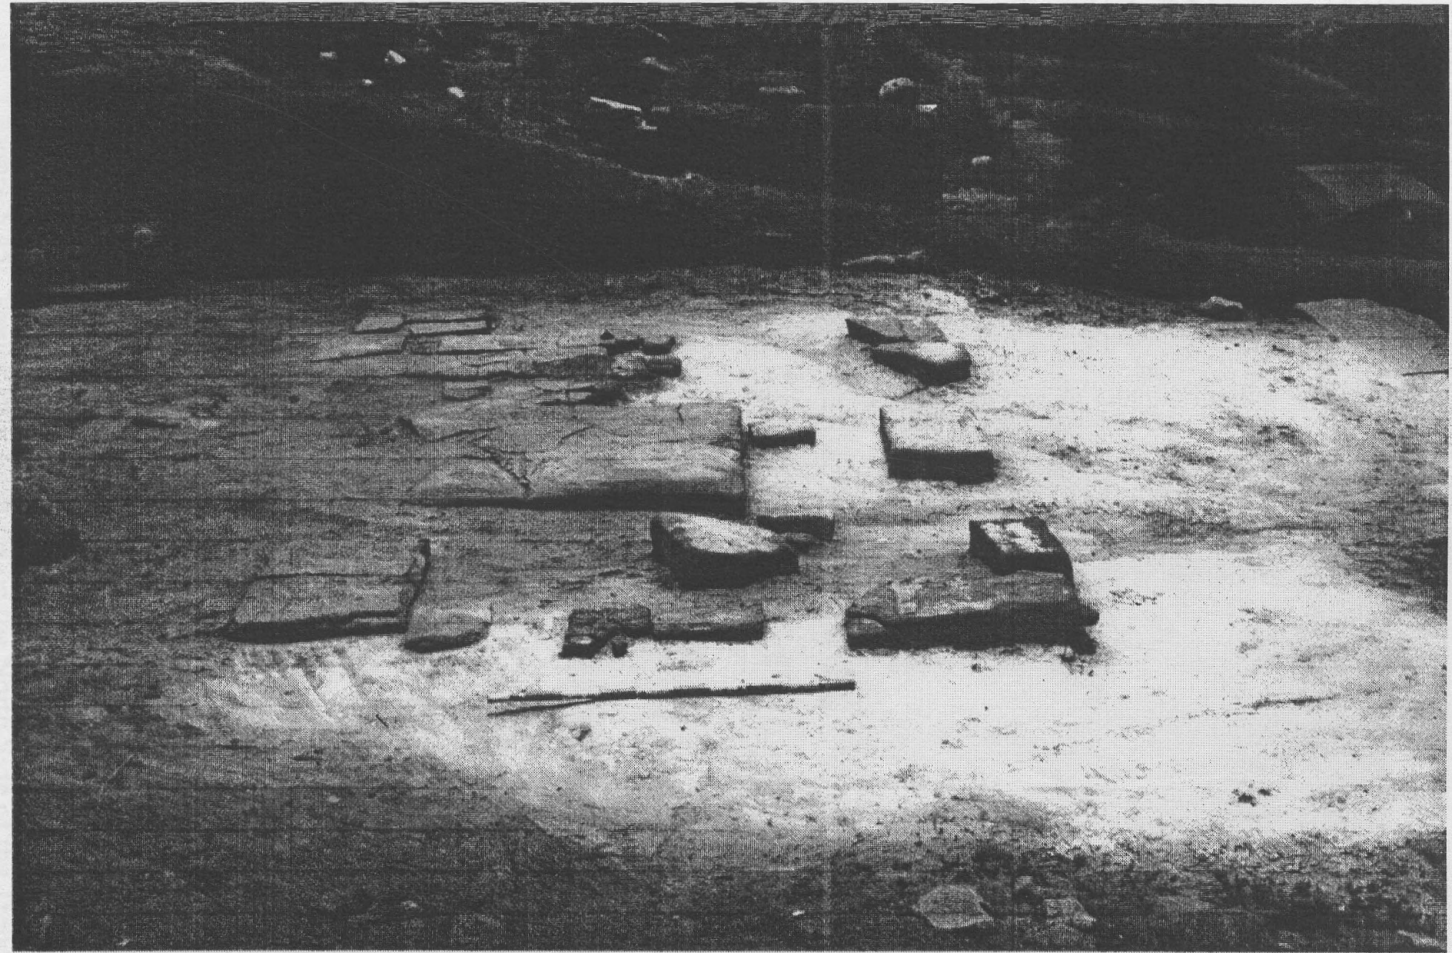
Figure 5.44: Trench P13, Feature 3, View Looking South. Feature 2 is to the West and Feature 7 is to the East.

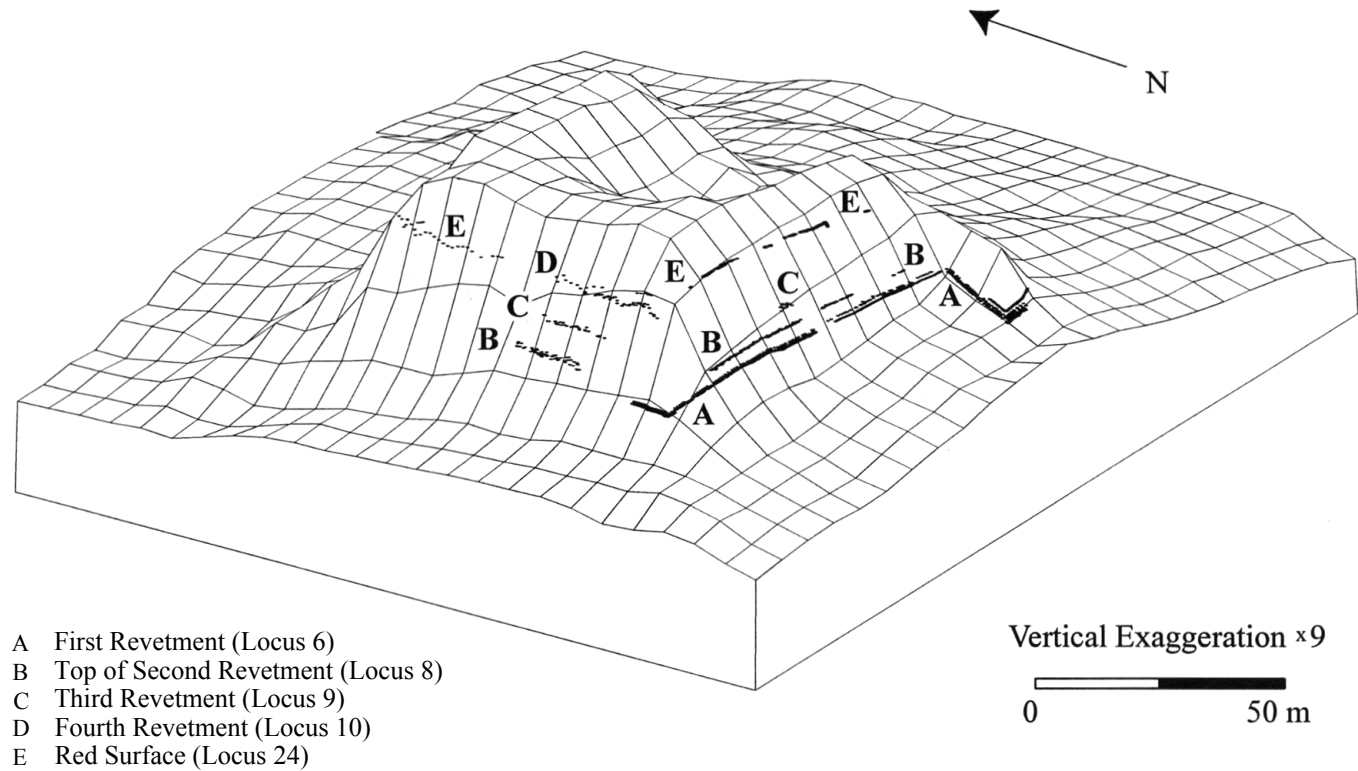
Figure 6.2: Southwest Side of the Main Platform, Showing the Revetments and the Red Surface. Revetments on the West Side of the Main Platform are Indicated by Cimentation Stones.

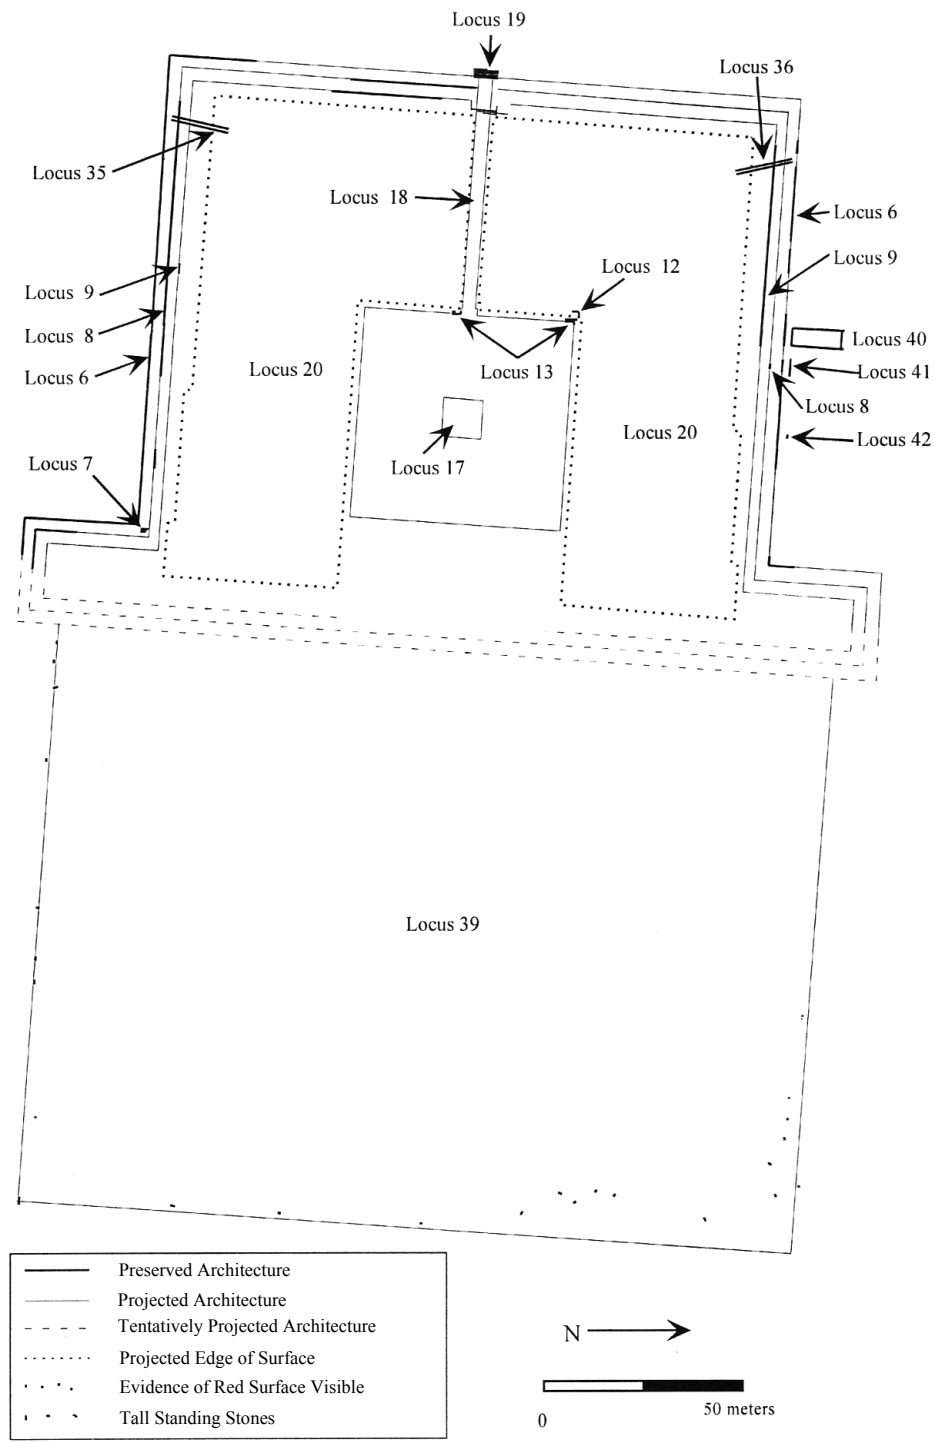
Figure 6.3: Reconstruction of the Pumapunku Complex Showing Major Loci, Including the Green Surface (Locus 20)

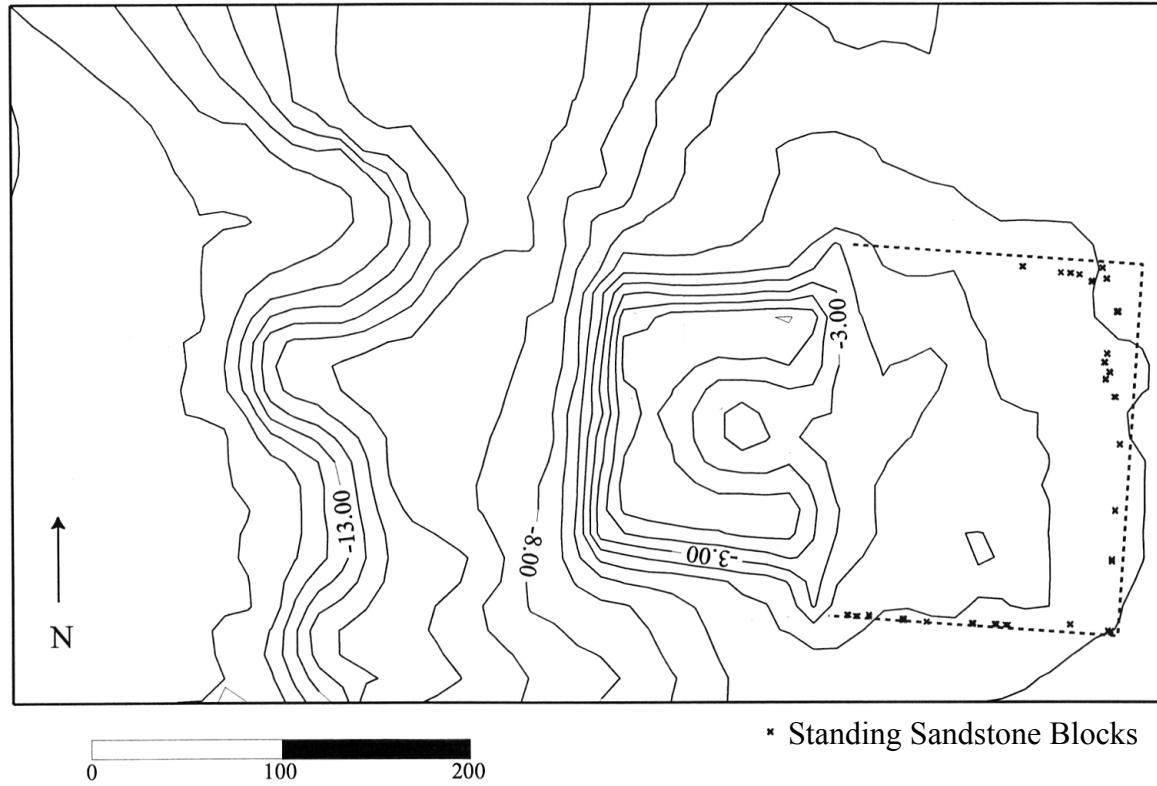
Figure 6.13: Contour Map of the Pumapunku Complex showing the Distribution of Extant Sandstone Blocks East of the Main Platform. Dashed Line Indicates Reconstructed Dimensions of the Eastern Plaza.

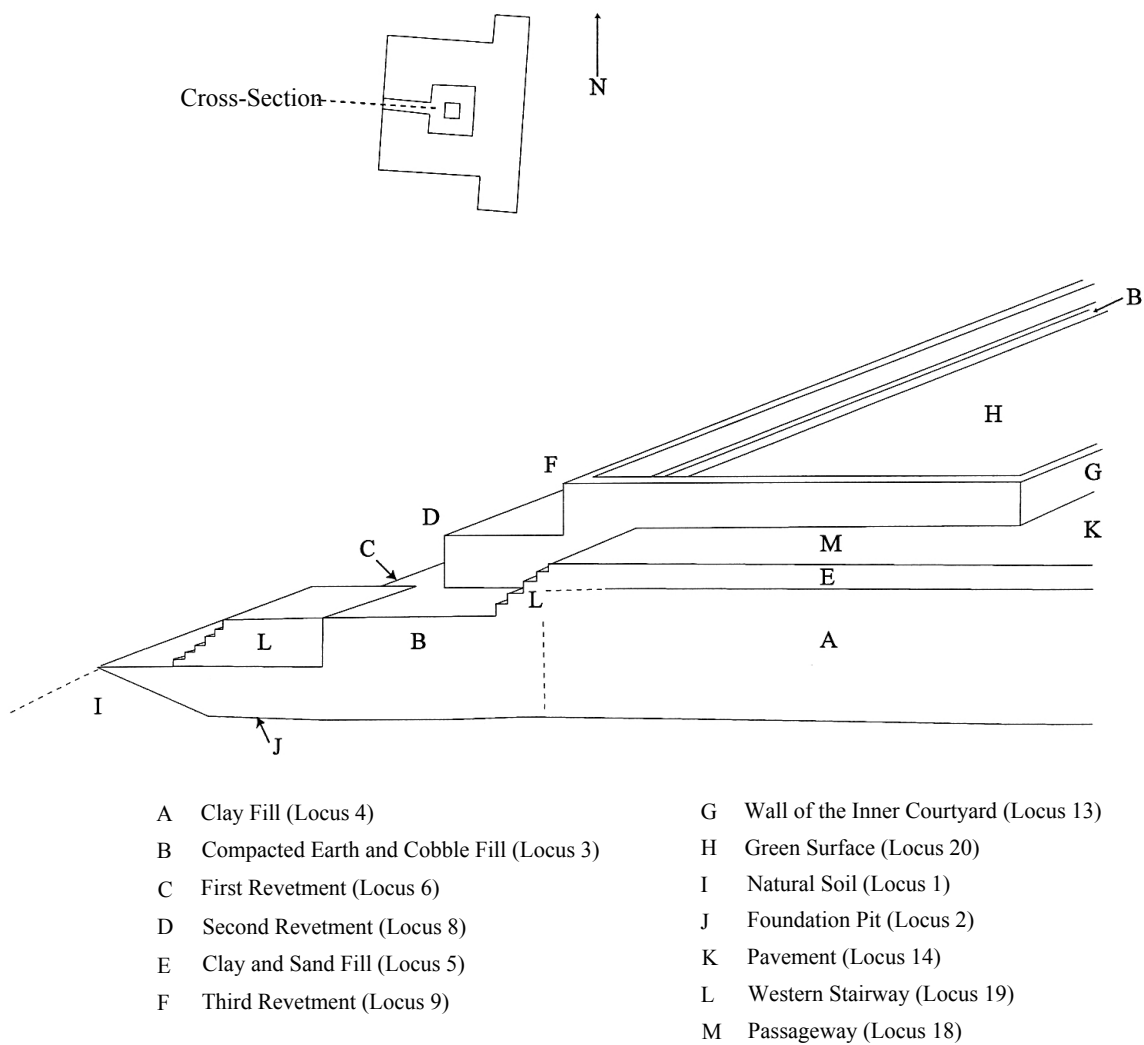
Figure 7.2: Schematic Cross-Section of the West Side of the Main Platform through the Passageway during Phase 1. Not to scale.

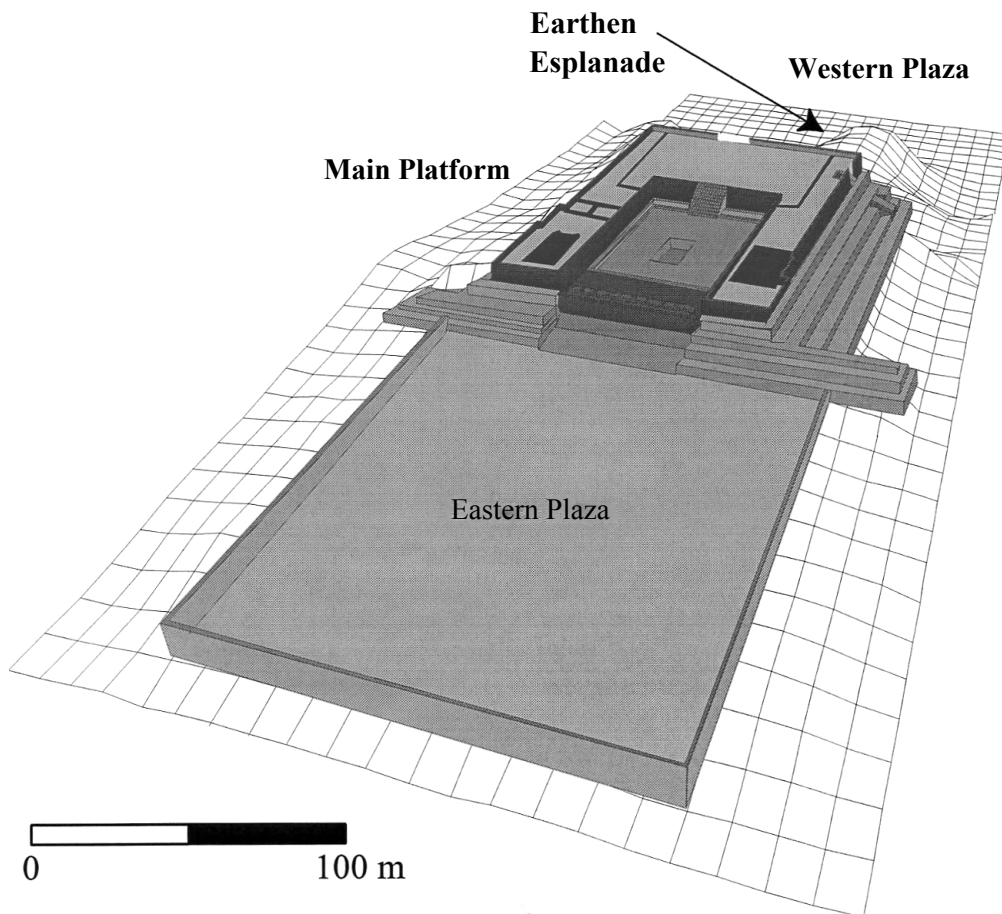
**Figure 8.3: Schematic Reconstruction of the Pumapunku Complex  
Seen from the East in Phase 3**

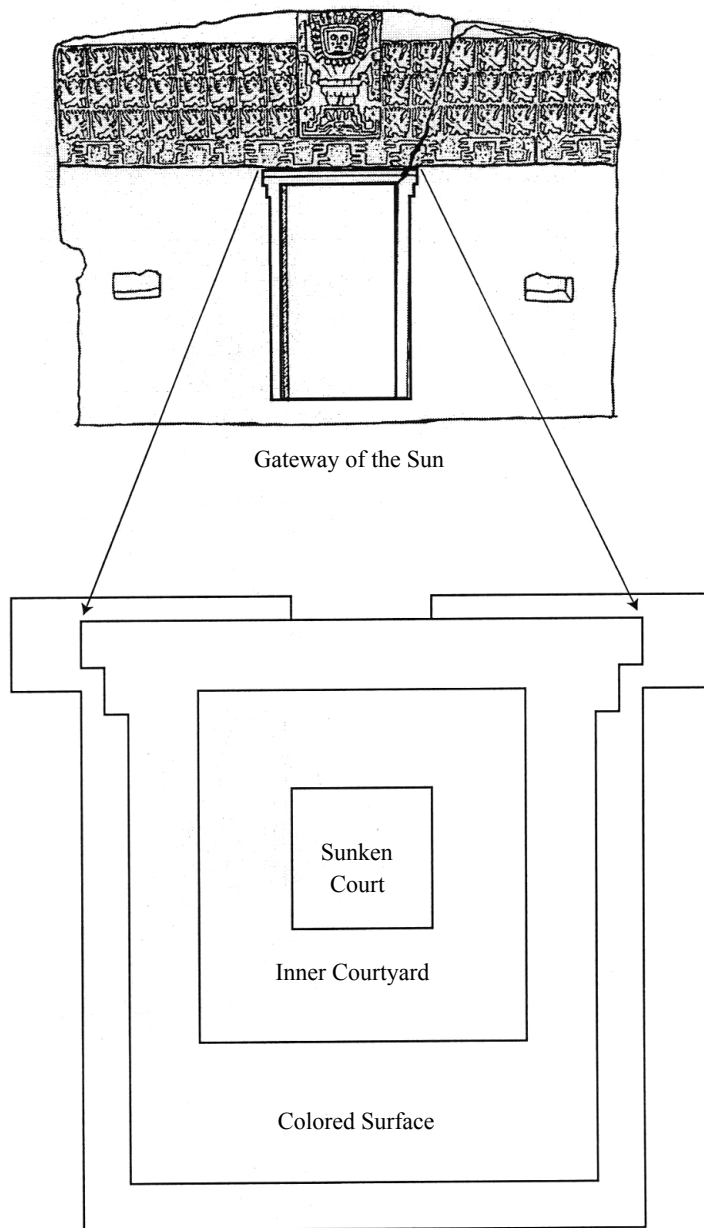
Figure 10.2: Comparison of the Major Features of the Main Platform of the Pumapunku with the Tiwanaku Doorway Motif. Schematic Drawing.
